BEACH EROSION CONTROL REPORT ON COOPERATIVE STUDY

U.S. ARMY ENGINEER DIVISION, NEW ENGLAND
CORPS OF ENGINEERS
WALTHAM, MASS.

OCTOBER 2, 1959

BEACH EROSION CONTROL REPORT ON COOPERATIVE STUDY OF THE SHORE OF CAPE COD
BETWEEN THE CAPE COD CANAL AND RACE POINT, PROVINCETOWN, MASSACHUSETTS

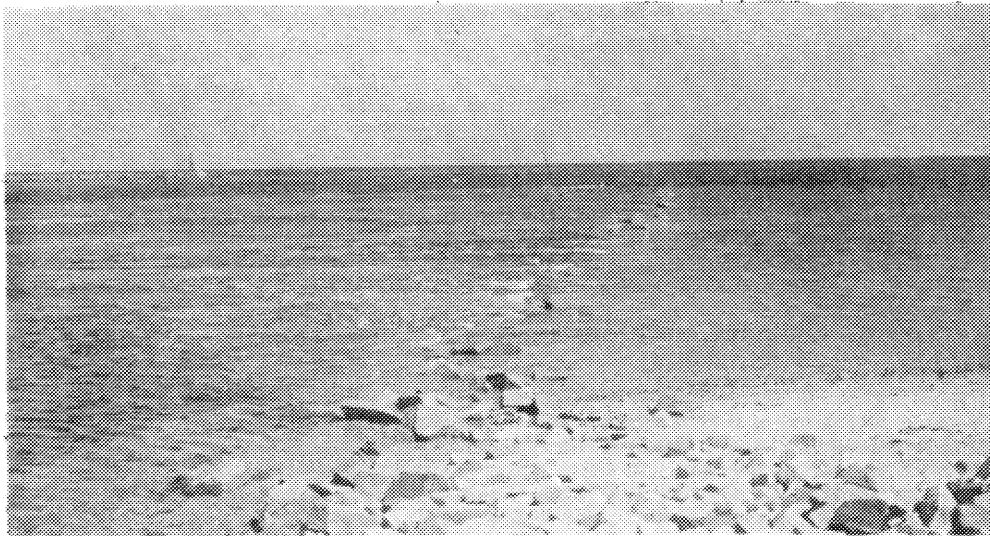
Fig. 1 Cape Cod Canal Entrance, Sandwich. 7 April 1959 -
Looking east along jetty. Note flow over jetty
into canal.

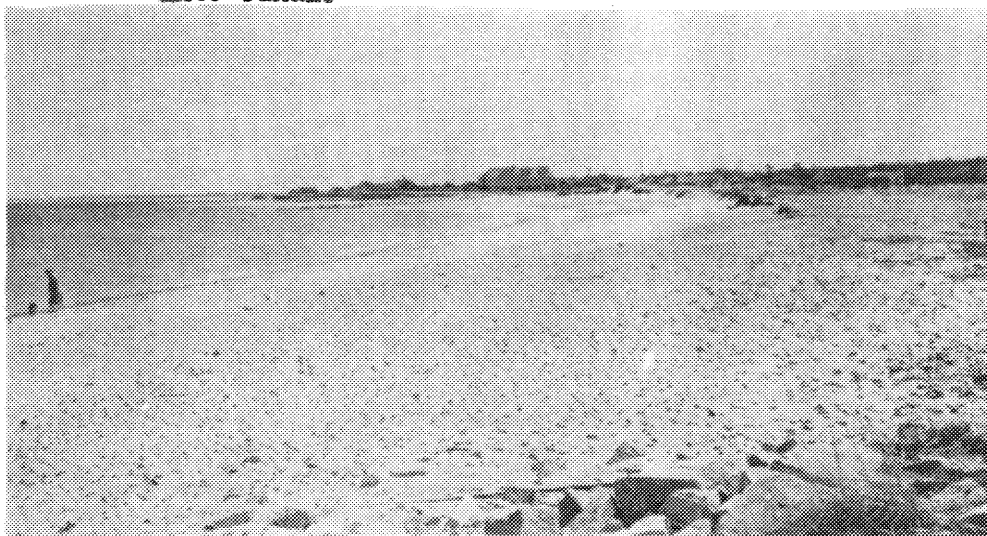
Fig. 2 Town Neck Beach, Sandwich. 7 April 1959 - Looking
southeasterly along beach from Cape Cod Canal jetty.

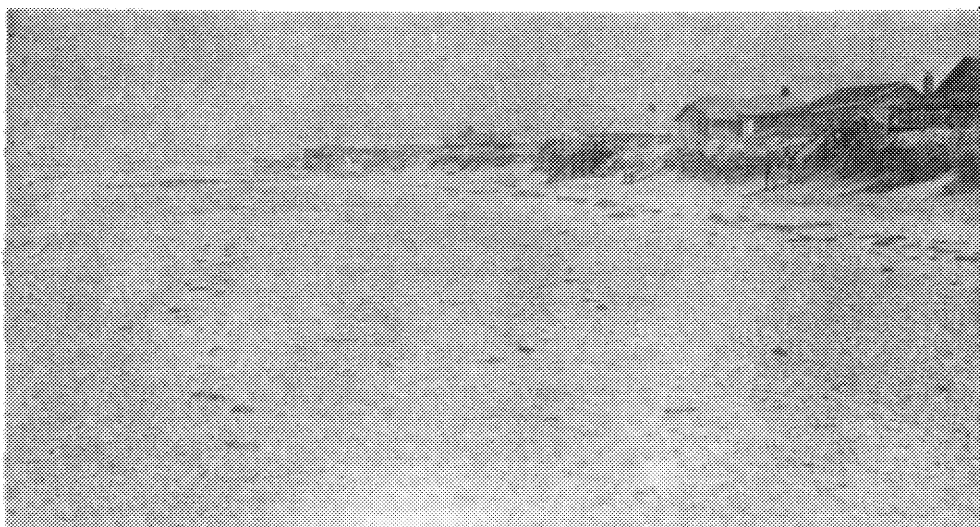
Fig. 3 Spring Hill Beach, Sandwich. 13 May 1958 - Easter-
ly along beach from a point east of Sandwich Harbor.

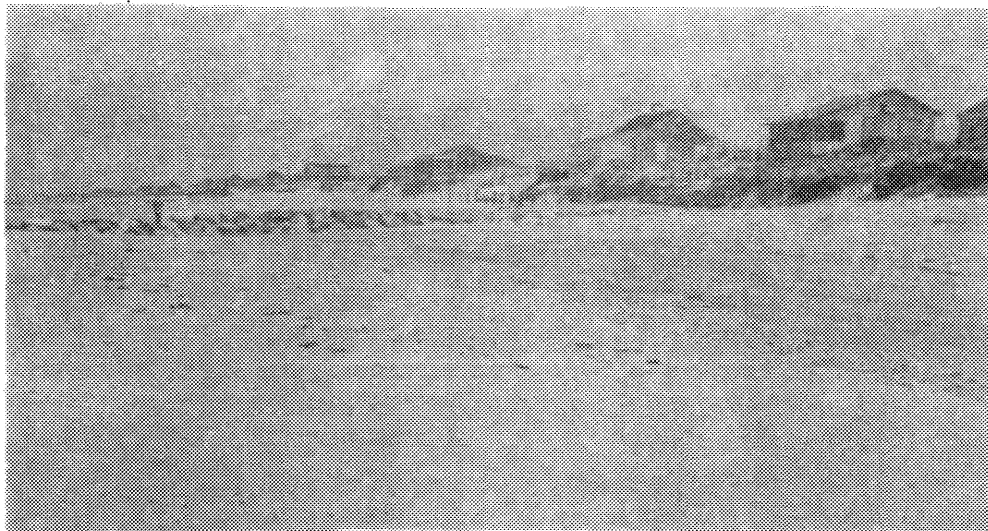
Fig. 4 Spring Hill Beach, Sandwich. 13 May 1958 - Easterly toward east end of beach.

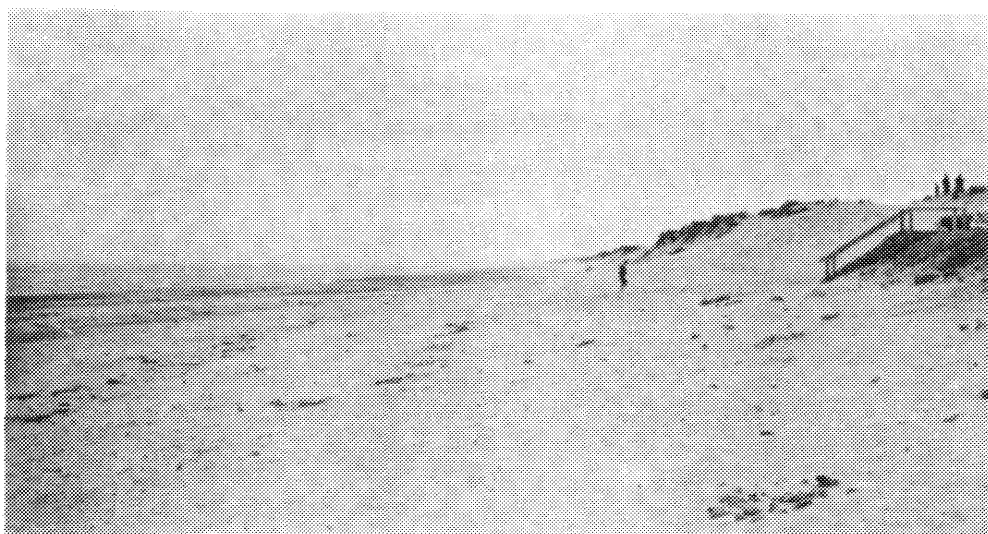
Fig. 5 Sandy Neck Beach, Barnstable. August 1958 - At developed public beach area looking easterly toward outer end of Sandy Neck.

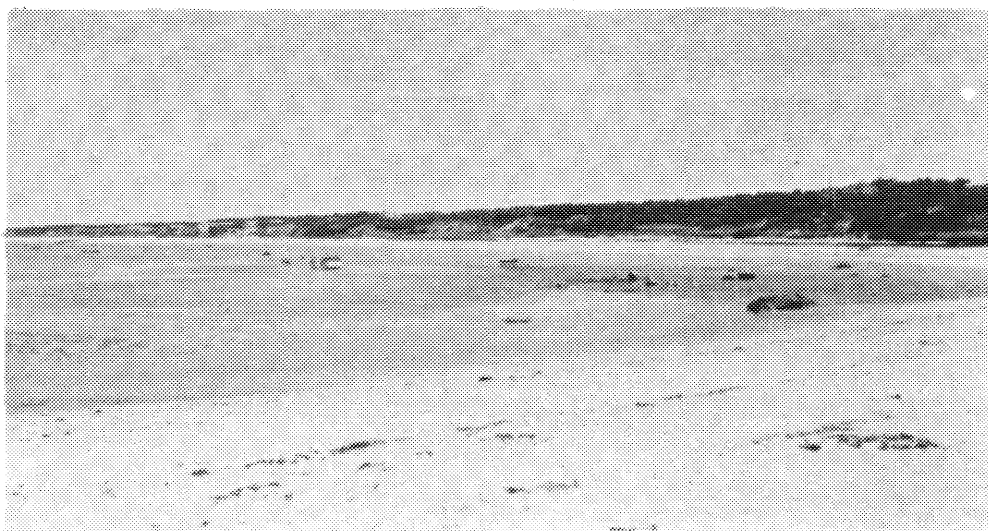
Fig. 6 Brewster Bluffs Area, Brewster. 12 August 1958 - From vicinity of Point of Rocks looking easterly toward detailed study area.

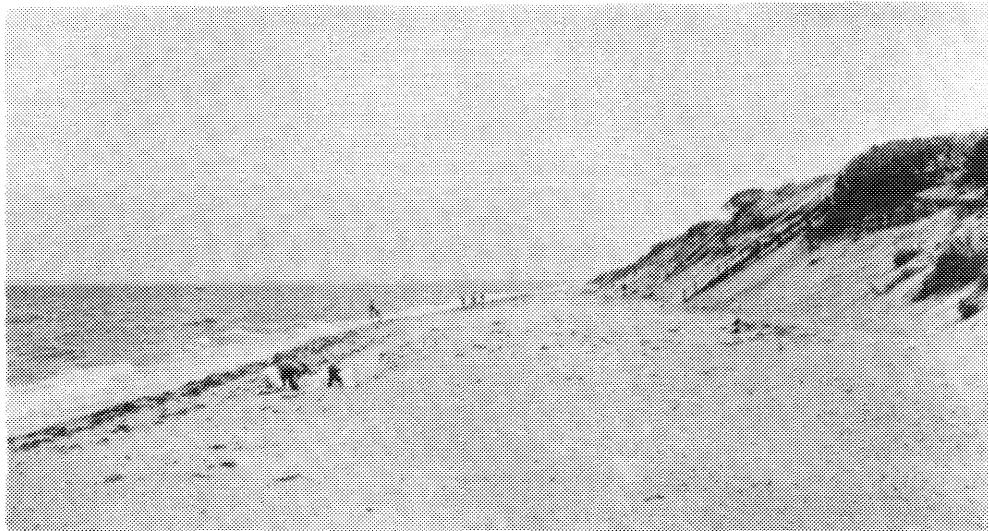
Fig. 7 Thumpertown Beach, Eastham. 13 August 1958 - Looking northerly along public beach area.

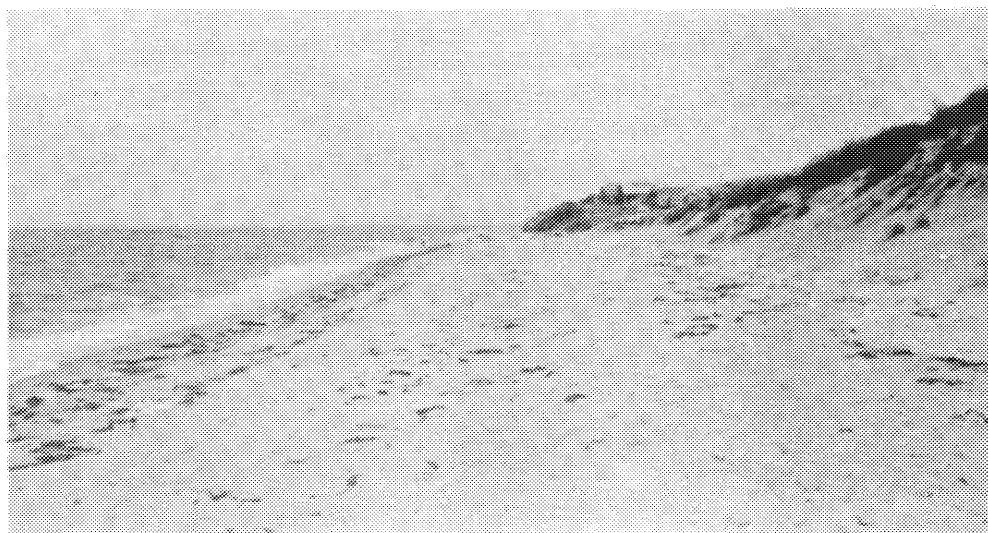
Fig. 8 Campground Landing Beach, Eastham. 13 August 1958 - Looking northerly along public beach area.

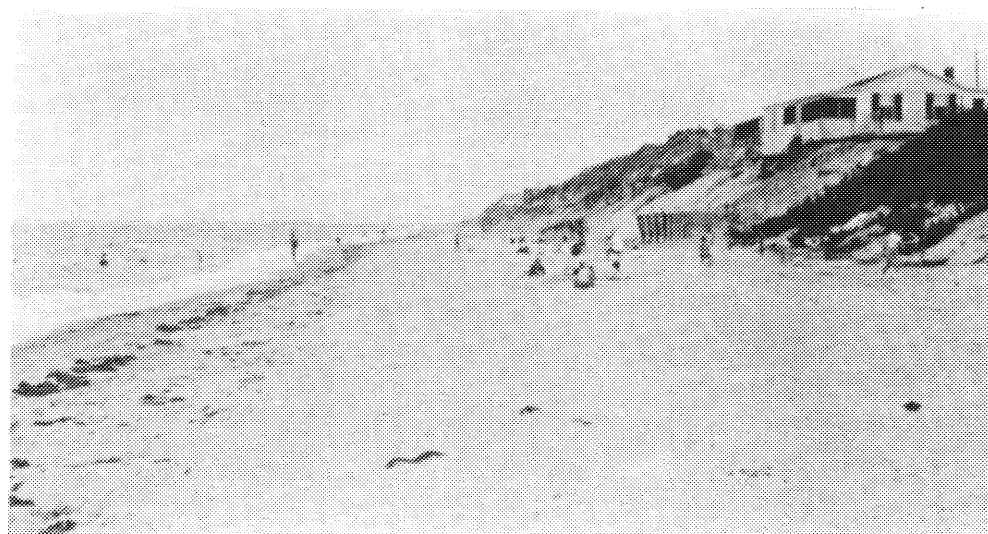
Fig. 9 Silver Spring Beach, Eastham. 13 August 1958 - Looking northerly along public beach area.

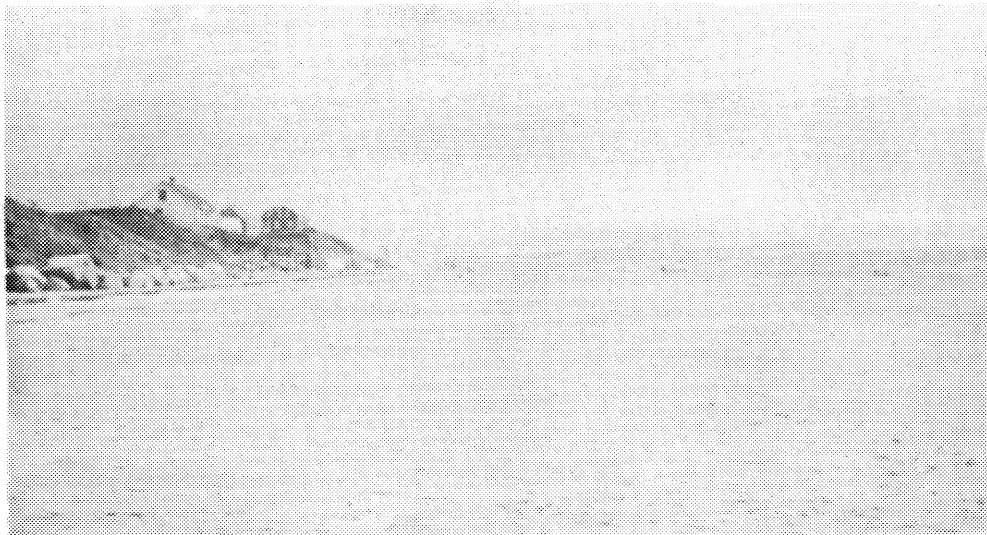
Fig. 10 Indian Neck, Wellfleet. 13 August 1958 - Looking southerly along beach from area of public access.

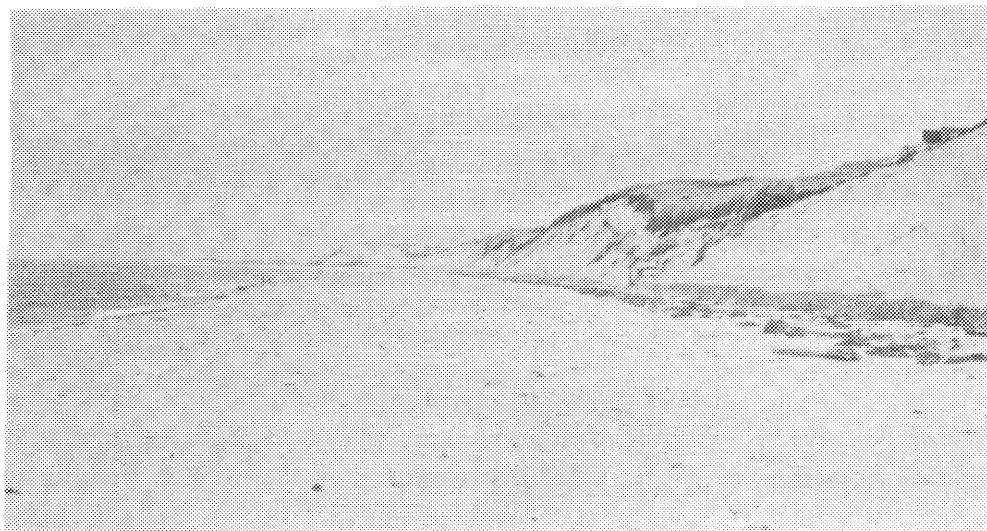
Fig. 11 Griffin Island, Wellfleet. 19 August 1958 - Looking north along public beach at Chequesset Neck Road

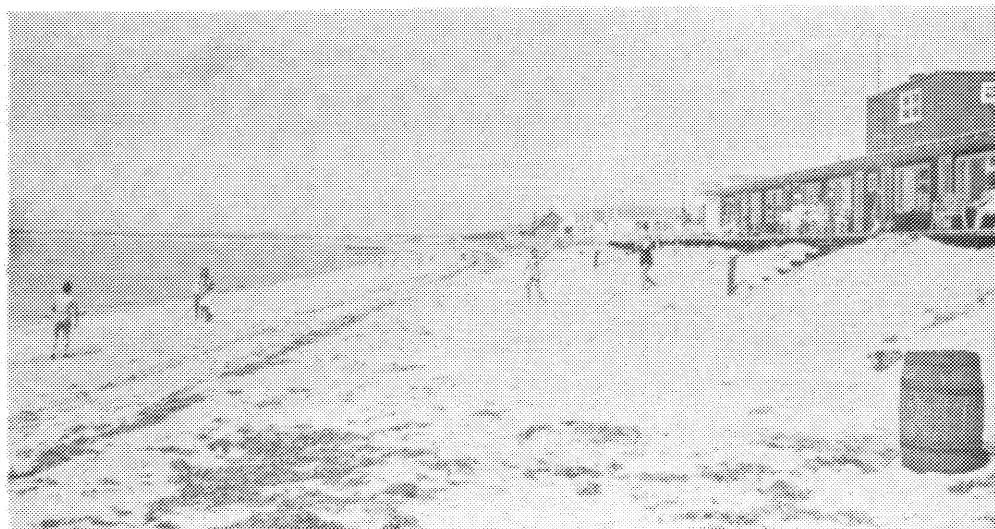
Fig. 12 Pilgrim Beach, Truro. 20 August 1958 - Looking northerly along motel area from public landing.

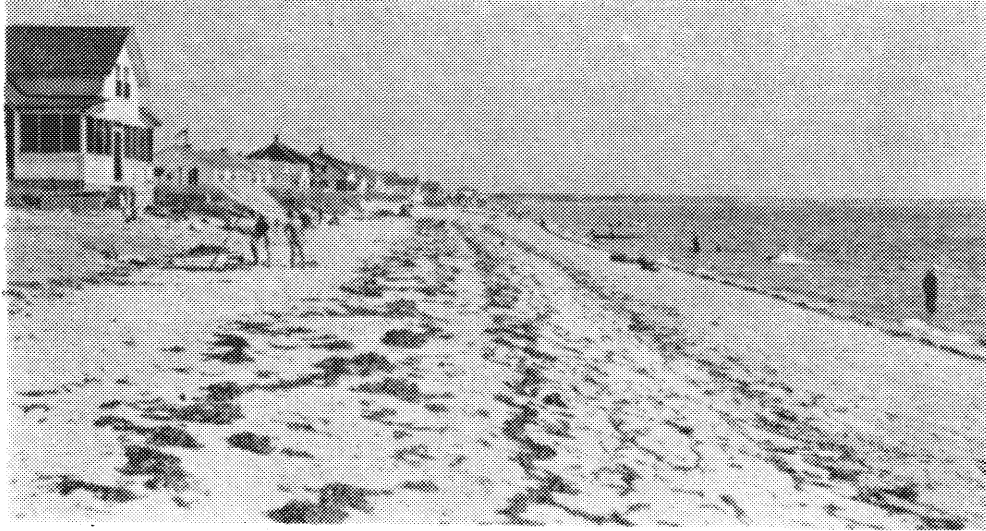
Fig. 13 Pilgrim Beach, Truro. 20 August 1958 - Looking southerly along beach from a point near north end.

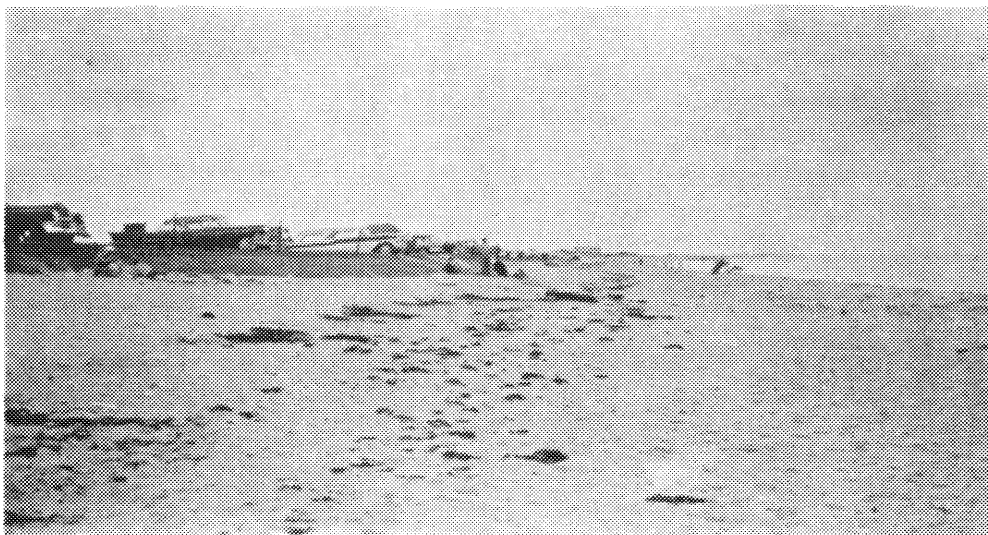
Fig. 14 Provincetown (new) Beach, Provincetown. 28 August 1958 - Looking south along beach.

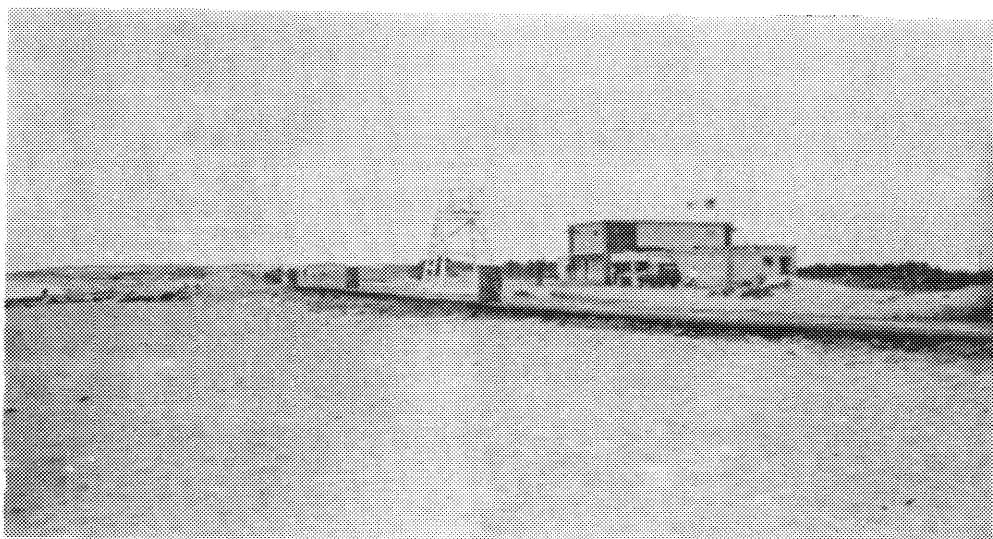
Fig. 15 Provincetown (new) Beach, Provincetown. 28 August 1958 - Bath house and facilities near south end of developed beach.

33. Provincetown Beach, Provincelands. - This beach is developed for about 4,000 feet. However, the principal damage is occurring in the southerly 1,600 feet of shore fronting the bath house. The most feasible plan for this beach consists of construction of 2 new groins and raise and extend 2 groins requiring about 21,500 tons of stone, direct placement of about 120,000 cubic yards of sand and construction of 1,200 feet of precast concrete seawall. The groins should be about 400 feet apart, have side slopes of 1 on 2 and be constructed with cover stone weighing 6 to 8 tons each along the seaward 200 feet and 3 to 5 tons on the remainder.
